WARTIME REPORT

AN INVESTIGATION OF A THERMAL ICE-PREVENTION SYSTEM
FOR A C-46 CARGO AIRPLANE

III - DESCRIPTION OF THERMAL ICE-PREVENTION EQUIPMENT
FOR WINGS, EMPENNAGE, AND WINDSHIELD

By Alun R. Jones and Ray J. Spies, Jr.

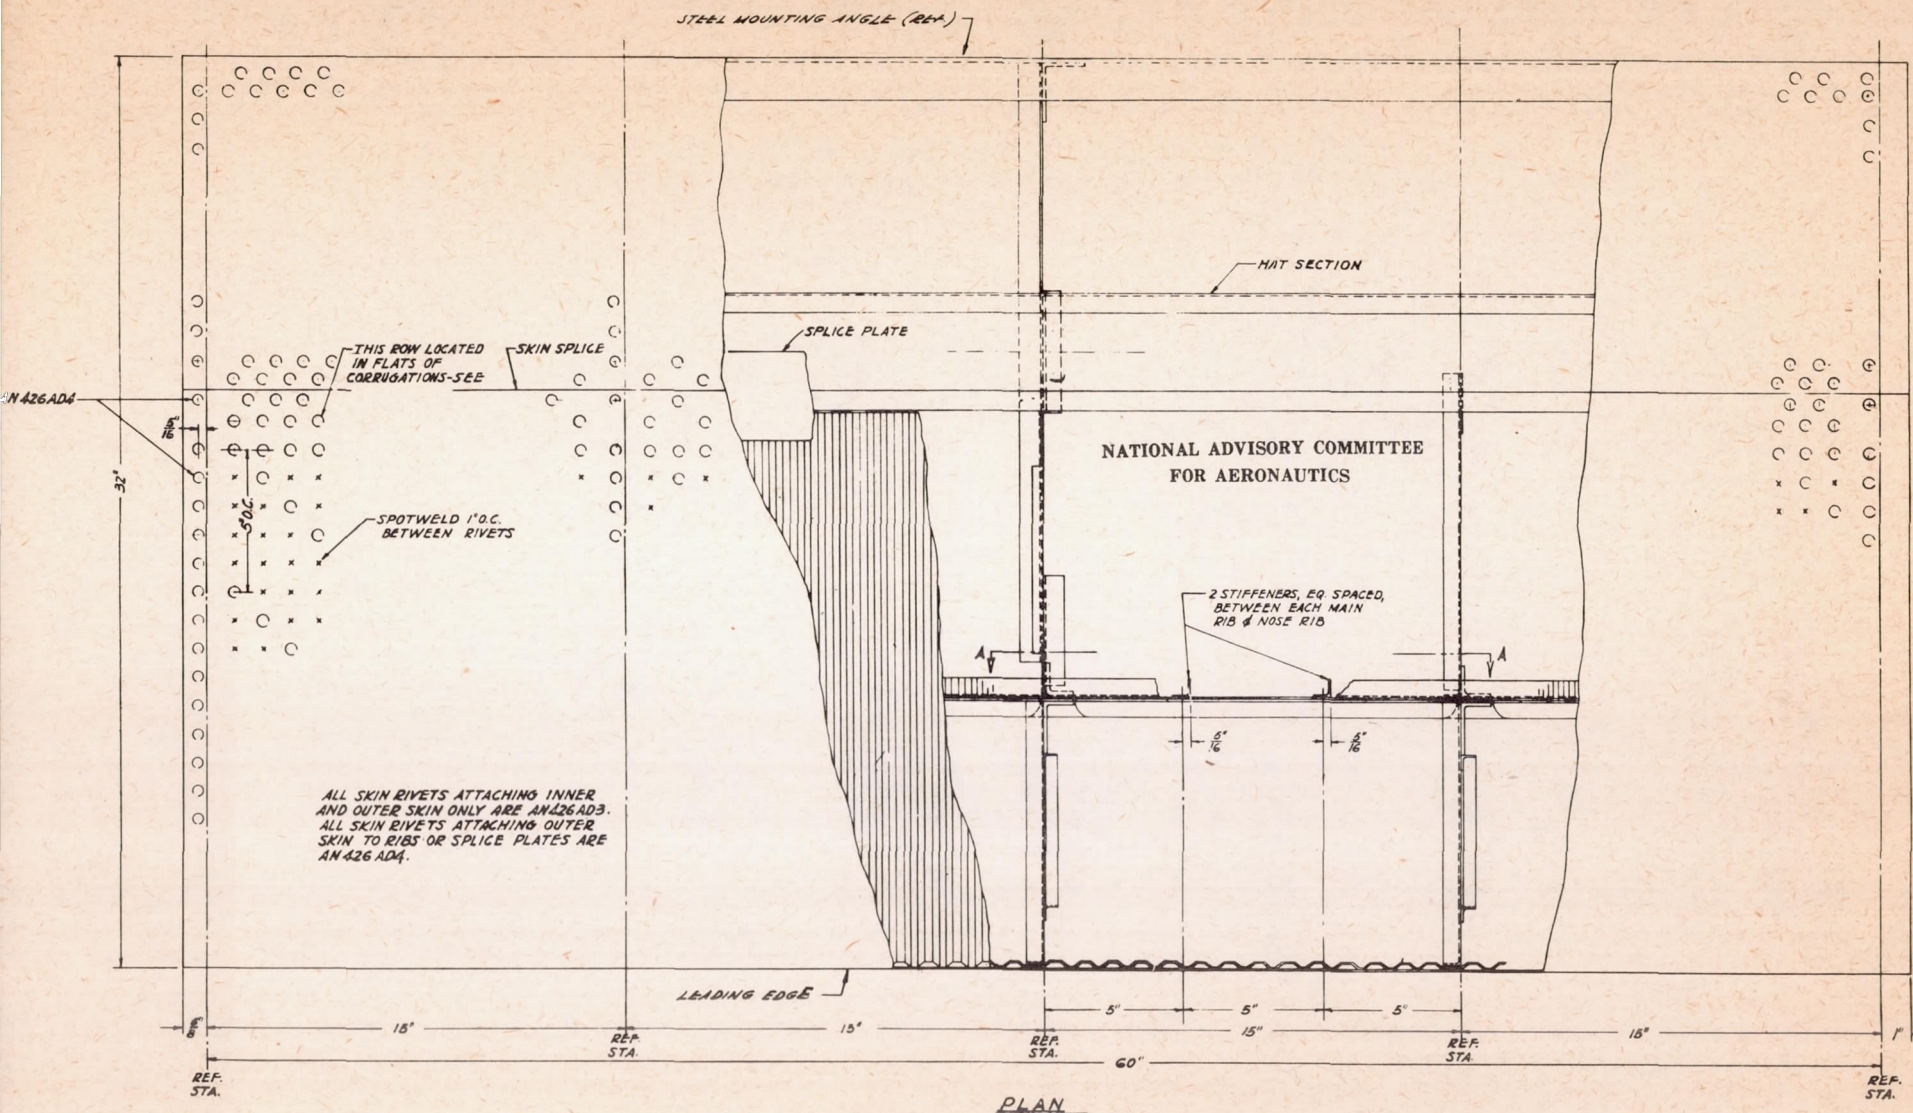
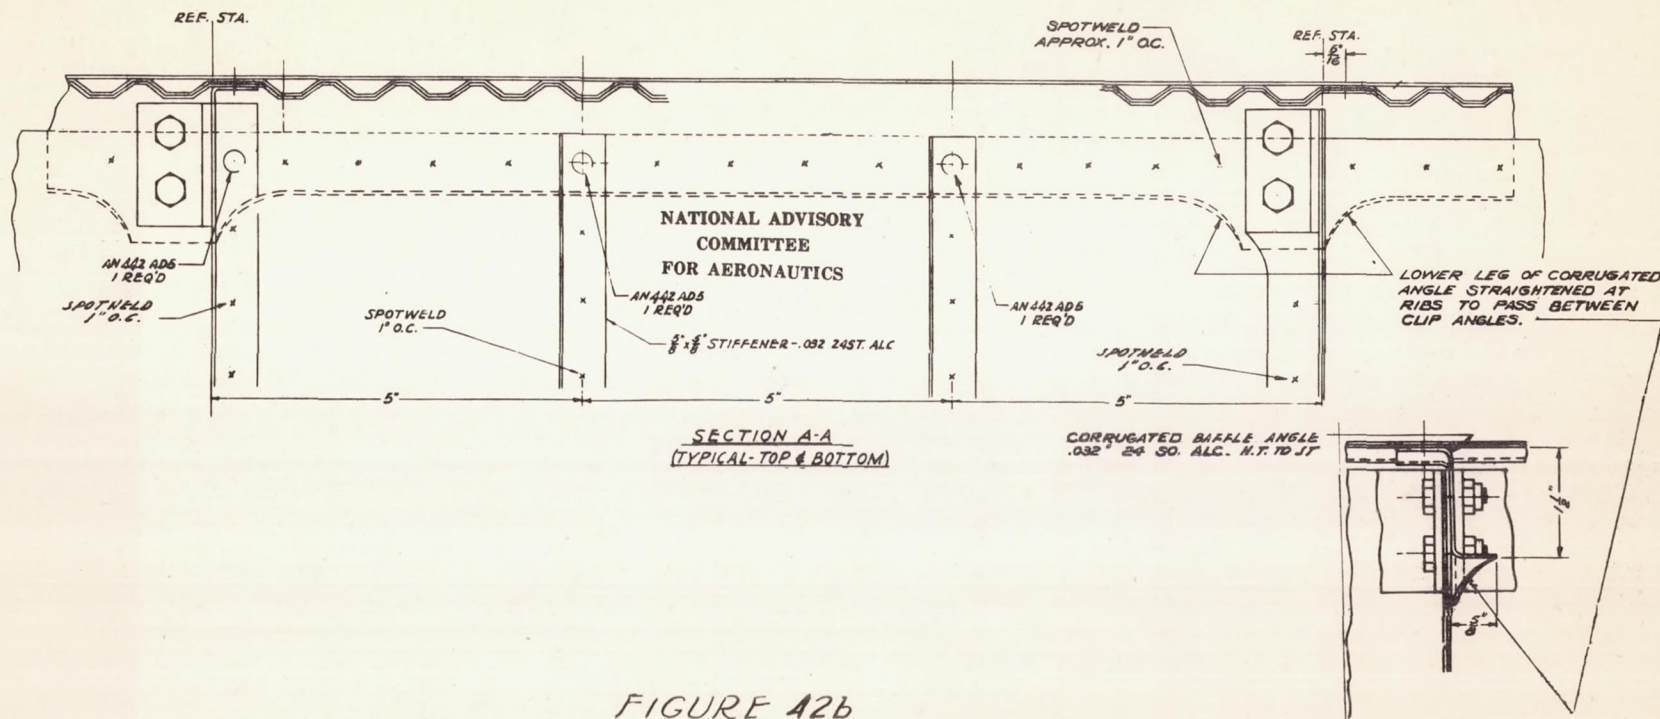
FIGURE 42a,b - ASSEMBLY OF WING OUTER PANEL LEADING EDGE
STATIC TEST SPECIMEN, C-46 AIRPLANE

The test specimen which was fabricated for the purpose of investigating the strength of the revised wing leading edge is shown in figures 42, 43, 44, and 45. The leading-edge contour of the specimen for the entire span was taken as that existing at wing station 22 (chord = 191.7 in.) and may be considered, with negligible error, as an NACA 23017 profile. The span of the specimen (60 in.) incorporated three main ribs and two intermediate ribs. After fabrication in the shops of AAL, the specimen was tested at the Buffalo, N.Y., Airport Plant of the Curtiss-Wright Corporation, Airplane Division. The test data presented herein are reproduced from a Curtiss-Wright report. The tests were conducted by Messrs. J. Kline and M. J. Berman under the supervision of Mr. E. L. Dashefsky, C-46 Structures Project Leader, and were made available for inclusion in this report through the courtesy of the Curtiss-Wright Corporation.

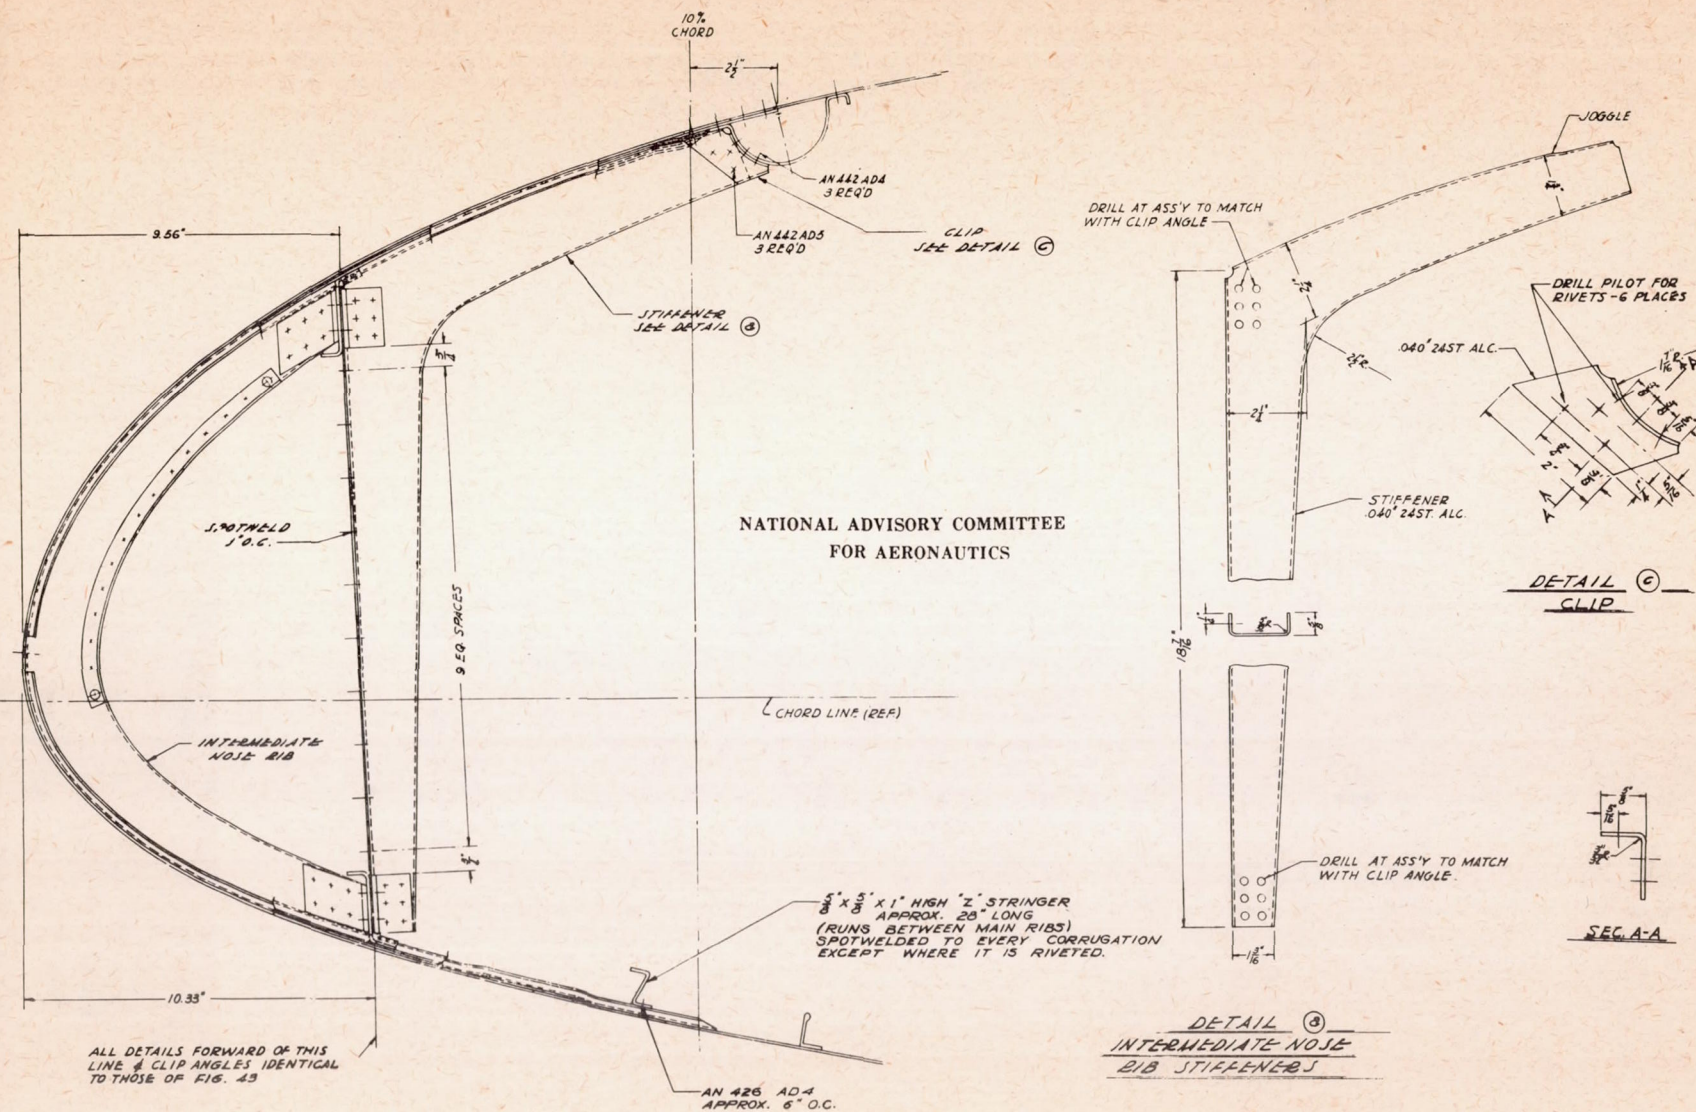
FIGURE 45 - INTERMEDIATE RIB DETAILS FOR WING OUTER PANEL LEADING
EDGE STATIC TEST SPECIMEN C-46 AIRPLANE

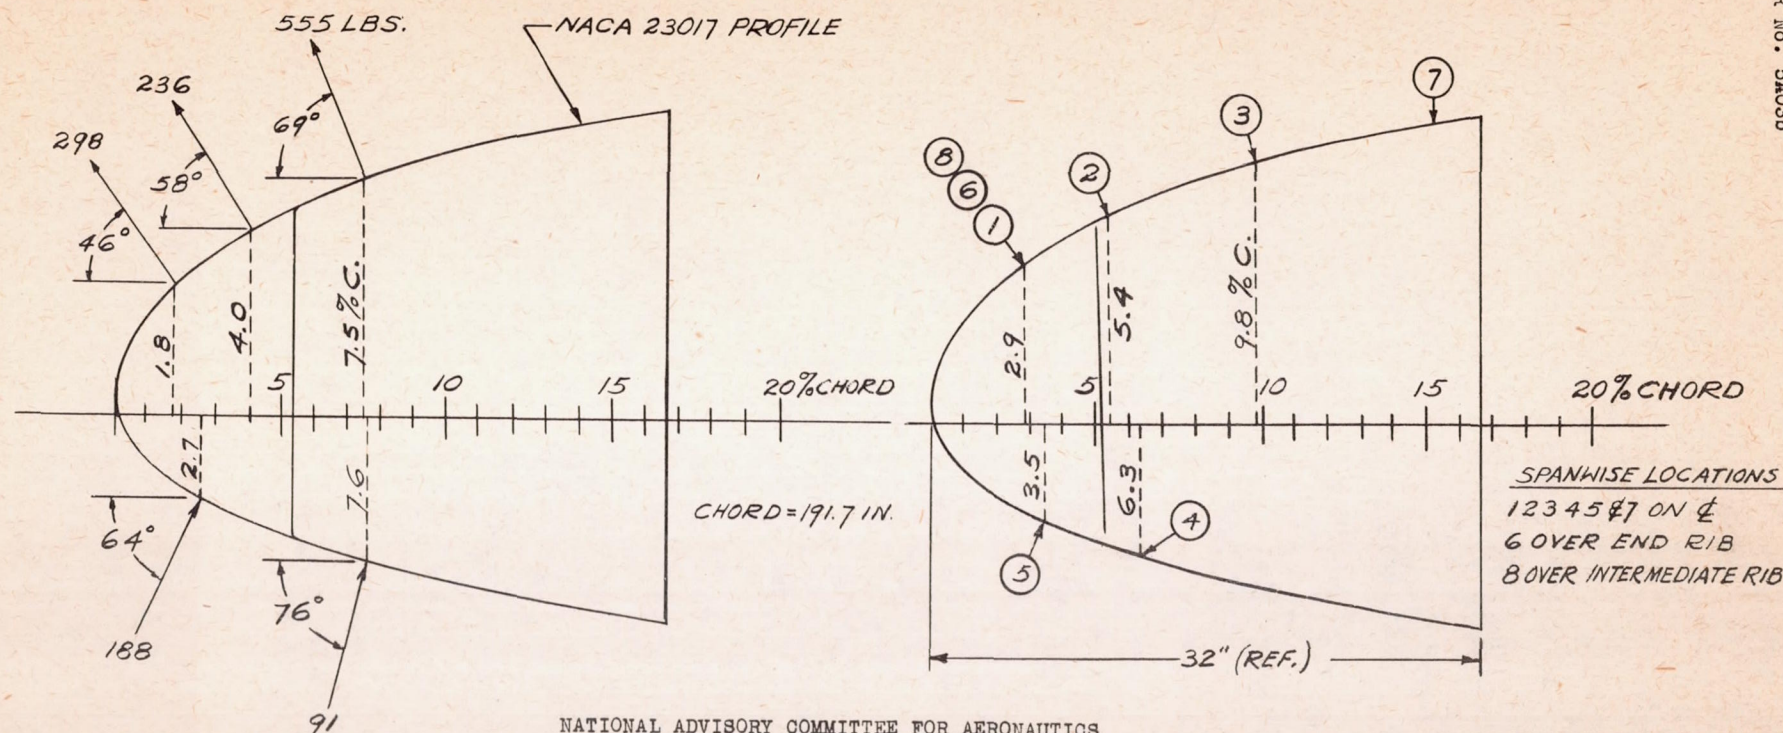
FIGURE 46.-MAGNITUDE, DIRECTION, AND LOCATION OF ULTIMATE LOADS FOR 15-INCH SECTION OF STATIC TEST SPECIMEN OF C-46 WING OUTER-PANEL LEADING EDGE.

Curtiss-Wright model 20 to meet the present requirements. The initial loads were increased by a factor of 1.25 to account for an increase in gross weight from 40,000 to 50,000 pounds and by a factor of 1.3 to allow for reduced yield strength in the structure as a result of elevated temperatures. The revised limit loads were therefore established as $1.25 \times 1.3 = 1.63$ times the initial limit loads. The ultimate loads were taken as 1.5 times the revised limit loads. The results of these load calculations are summarized in table I. The unit ultimate loads from table I were plotted to give a curve of chordwise loading. The areas under the curve were measured and centroids located from which the concentrated ultimate loading (shown in fig. 46 for 15 in. of span) was established.

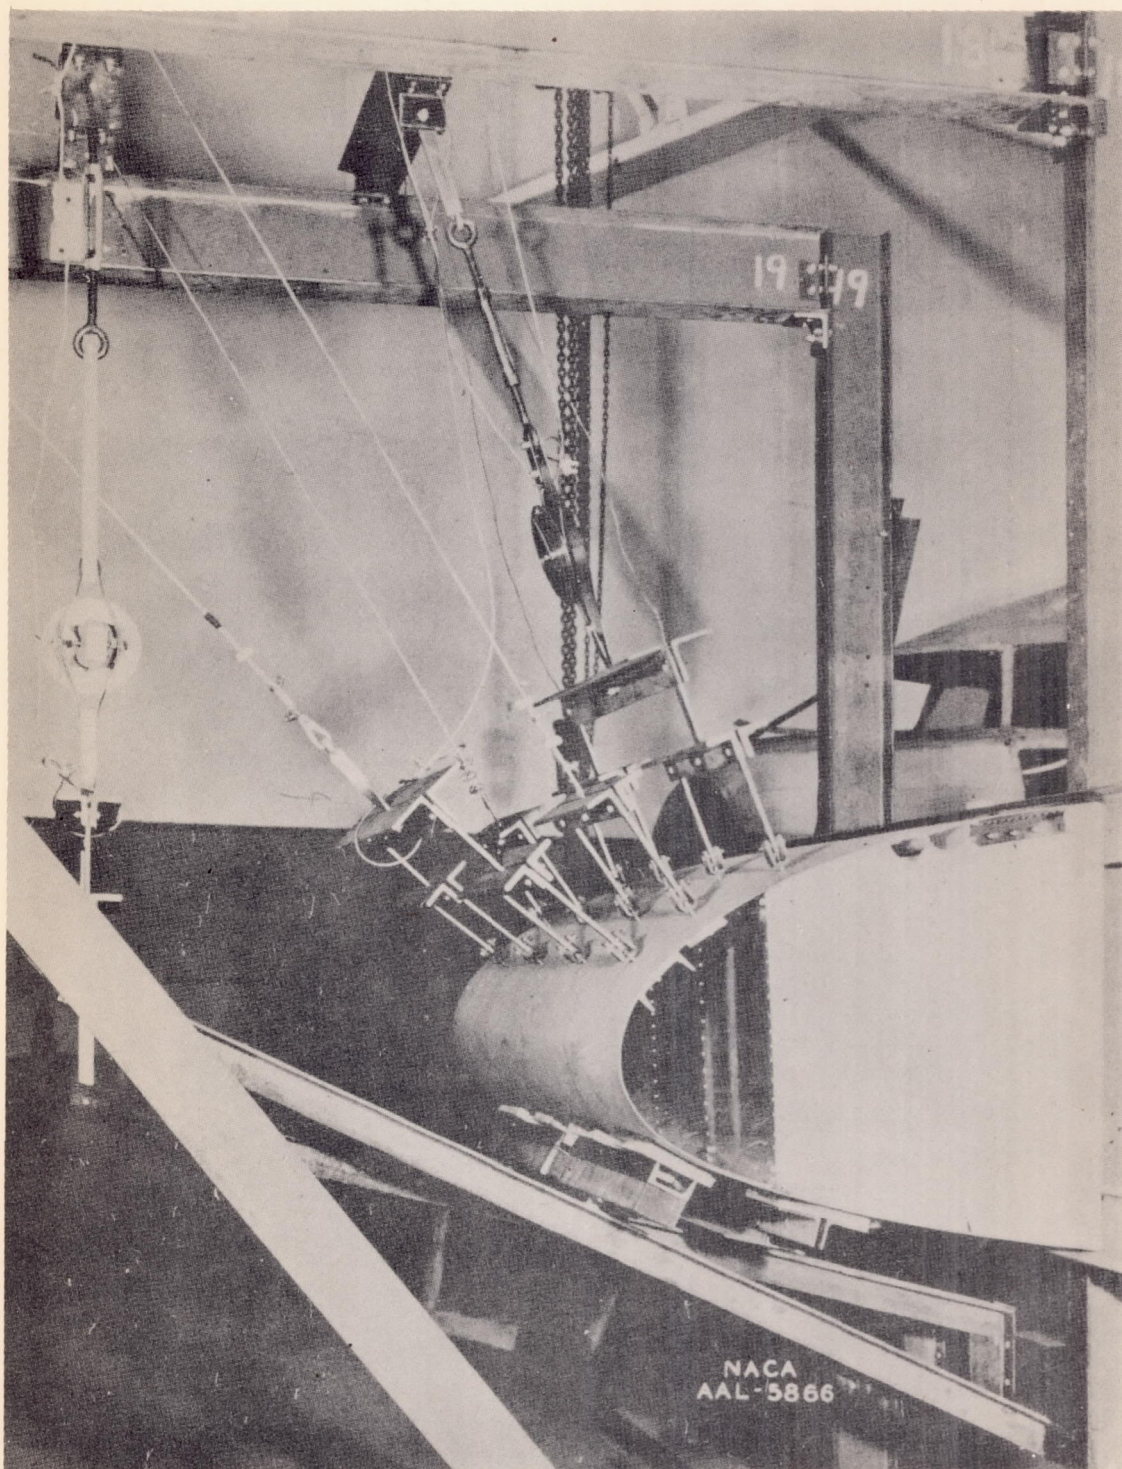
Figure 47.- Side view of system for applying static loads to structural test specimen of C-46 wing outer-panel leading edge.

The loads were applied to the specimen with the lever and whiffletree arrangement shown in figures 47 and 48. The steel mounting angles at the aft end of the specimen (fig. 42) were bolted to the test frame and all loads were applied and indicated with the three turnbuckle-dynamometer systems shown in figure 48. Upper-surface pull points were located at the center of each of the four rib bays, and the load was distributed over four corrugations through a steel-channel and wood-block installation as shown in figure 49. Distribution of the compression loads was effected with a steel-channel and felted-board arrangement which may be seen in figure 47.

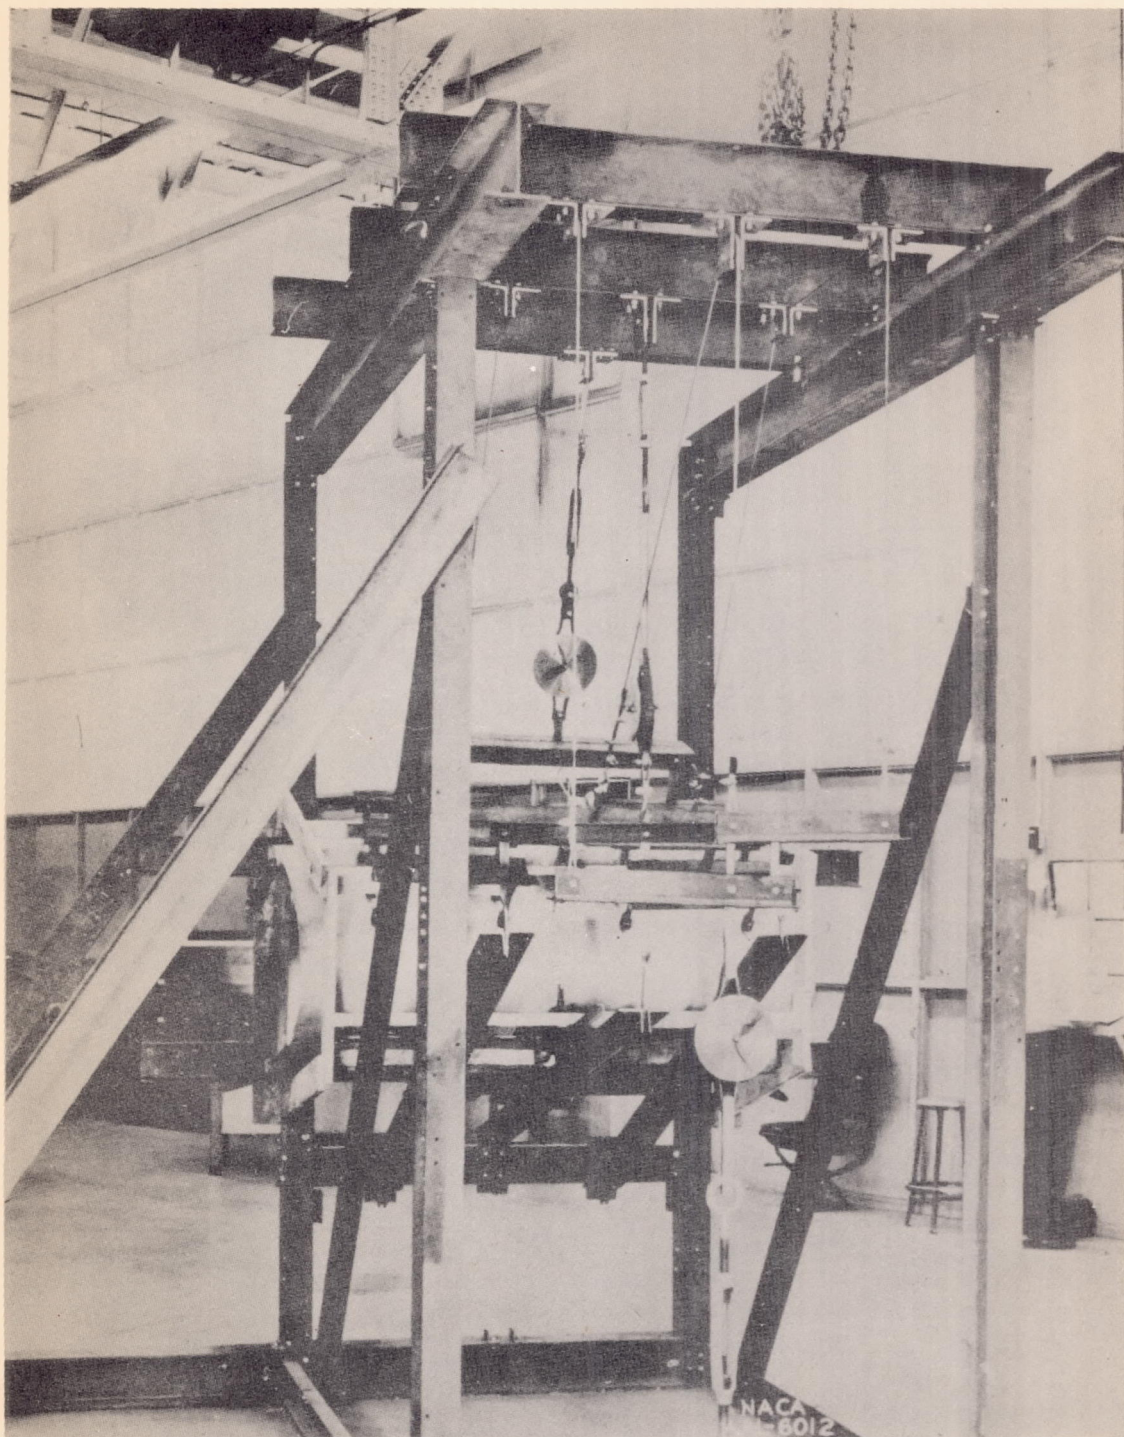
Figure 48.- Front view of system for applying static loads to structural test specimen of C-46 wing outer-panel leading edge.

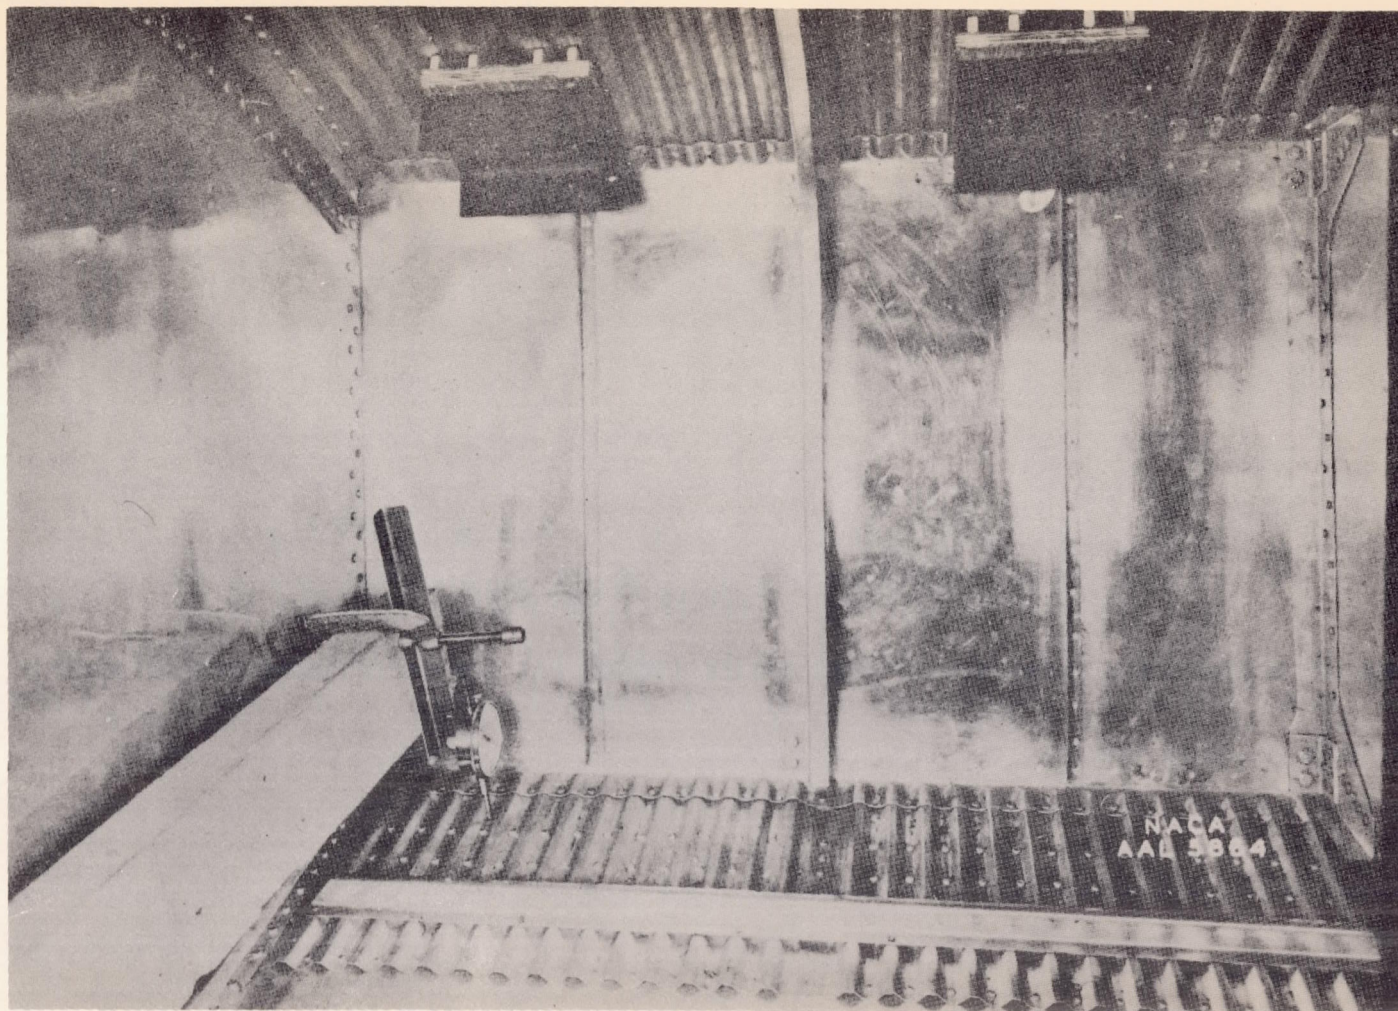
Figure 49.-- Rear view of C-46 wing leading-edge static test specimen showing channel and wood-block arrangement for distributing tension load to corrugations.

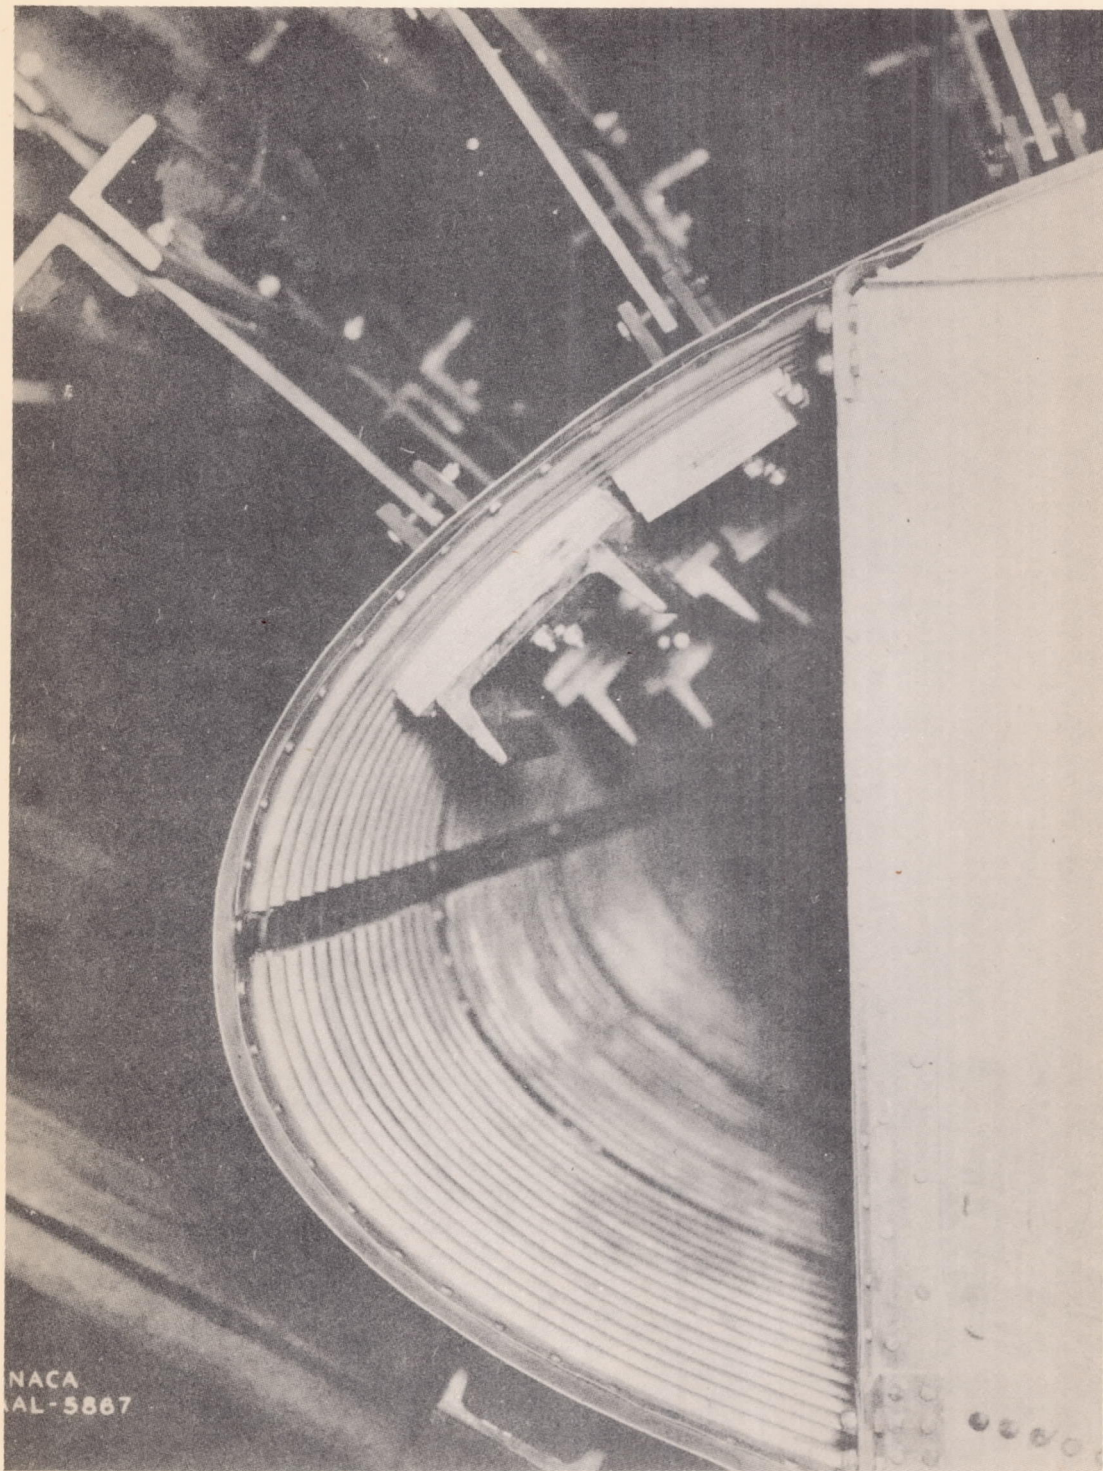
Figure 51.- Static test specimen of C-46 wing outer-panel leading edge as altered for test number 5.

Several Ames deflection dials were located around the specimen at the points shown in figure 50. These dials were attached to a wood frame which in turn was secured to the two steel channels at the rear of the specimen in order to minimize errors caused by deflections of the test frame. The loads were applied to the specimen in increments of 20 percent of the revised limit loads. For each test configuration initial loadings of 10 percent of the revised limit loads were applied to the specimen and the readings of the deflection dials were recorded. These readings were arbitrarily established as "zero" set. Subsequent to the application of loadings equal to or greater than 60 percent of the revised limit loads, the loads were reduced to the arbitrarily chosen loading of 10 percent of the revised limit loads and readings of the deflection dials were again recorded. A comparison of these readings with the zero-set readings established the set, or permanent deformation, produced by each load application. Five different configurations of the specimen were tested, the final form being completely without nose ribs as shown in figure 51. The alterations to the specimen for each

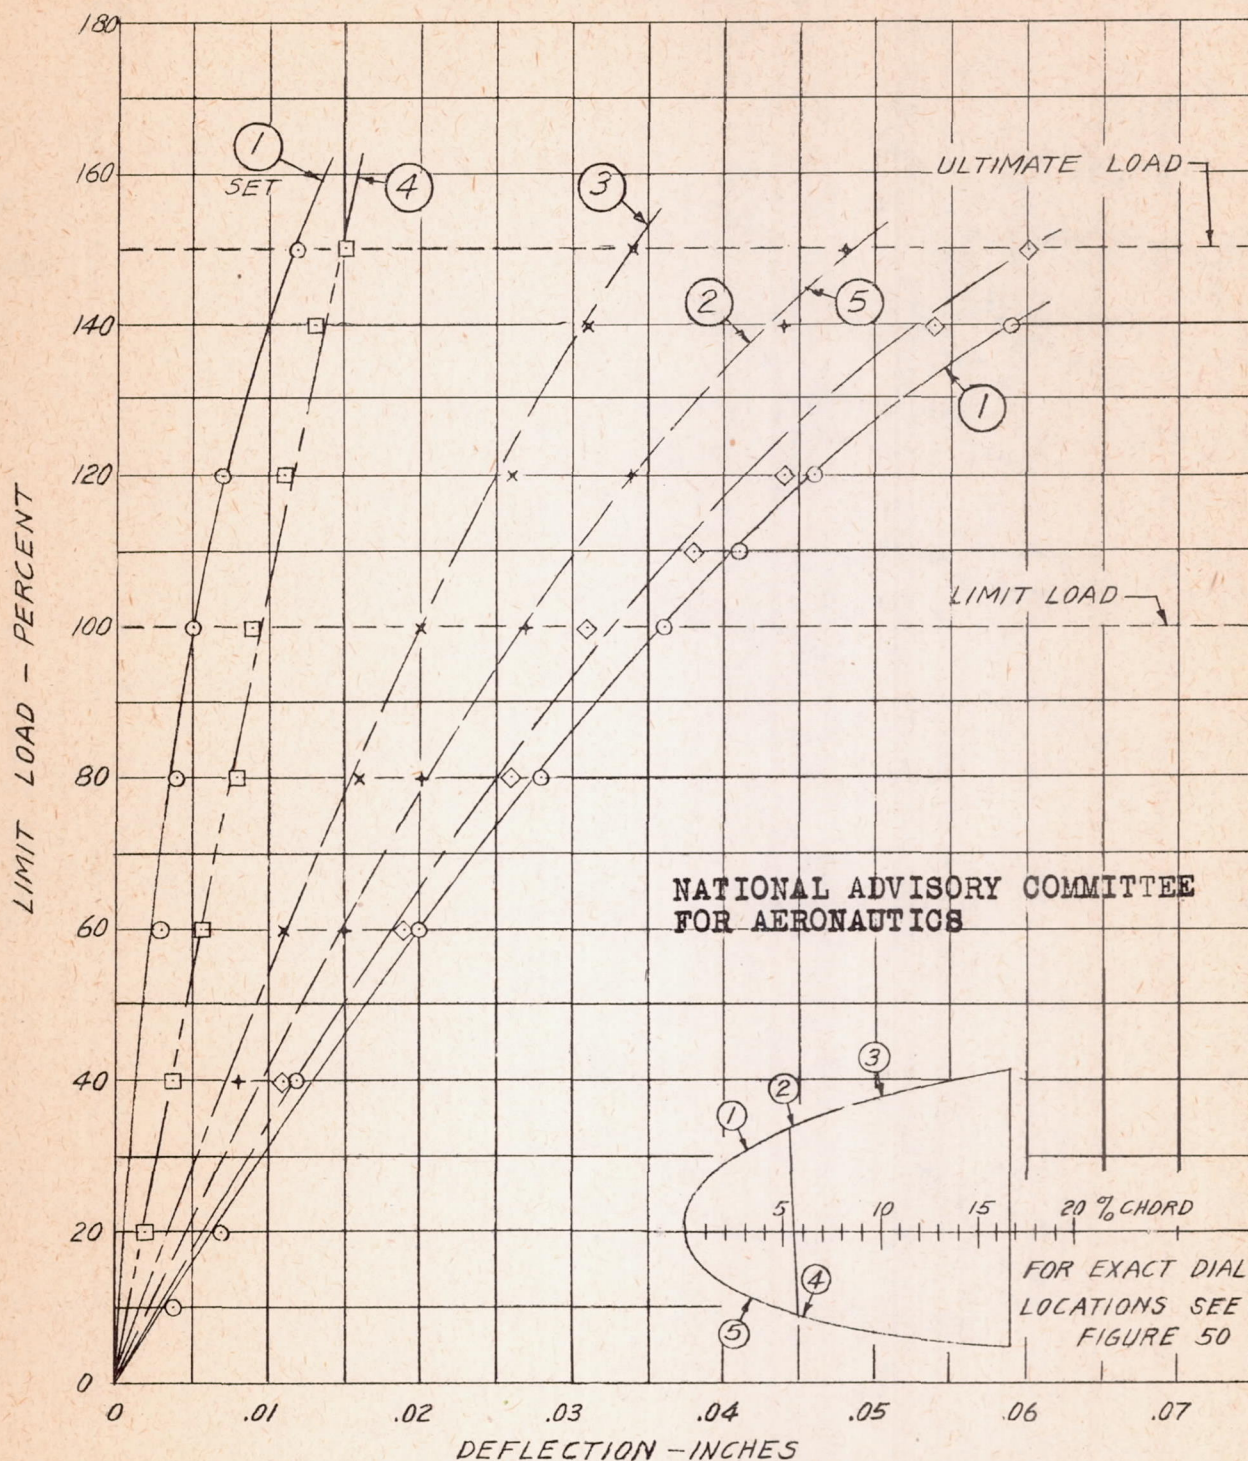
FIGURE 52.-DEFLECTIONS INDICATED BY AMES DIALS DURING
 STATIC TEST NUMBER ONE, C-46 WING OUTER-PANEL
 LEADING-EDGE SPECIMEN.

The deflections and sets for tests 1, 4, and 5 are presented in figures 52, 53, and 54, respectively. The deflections for tests 2 and 3 were approximately the same as for test 1 and are not presented. The test results indicate no appreciable change in maximum deflection until all the nose ribs were removed for test 5. From a structural standpoint the specimen was satisfactory in all tests since all deflection curves up to the limit load were straight lines, indicating that no yielding had taken place. The deflections of test 5, however, might be unsatisfactory from aerodynamic considerations. Of the five configurations tested, the number 4 arrangement is recommended for future use, although consideration should be given to the possible further weight reduction to be obtained through the use of thinner sheet for the fabrication of some parts of the system.

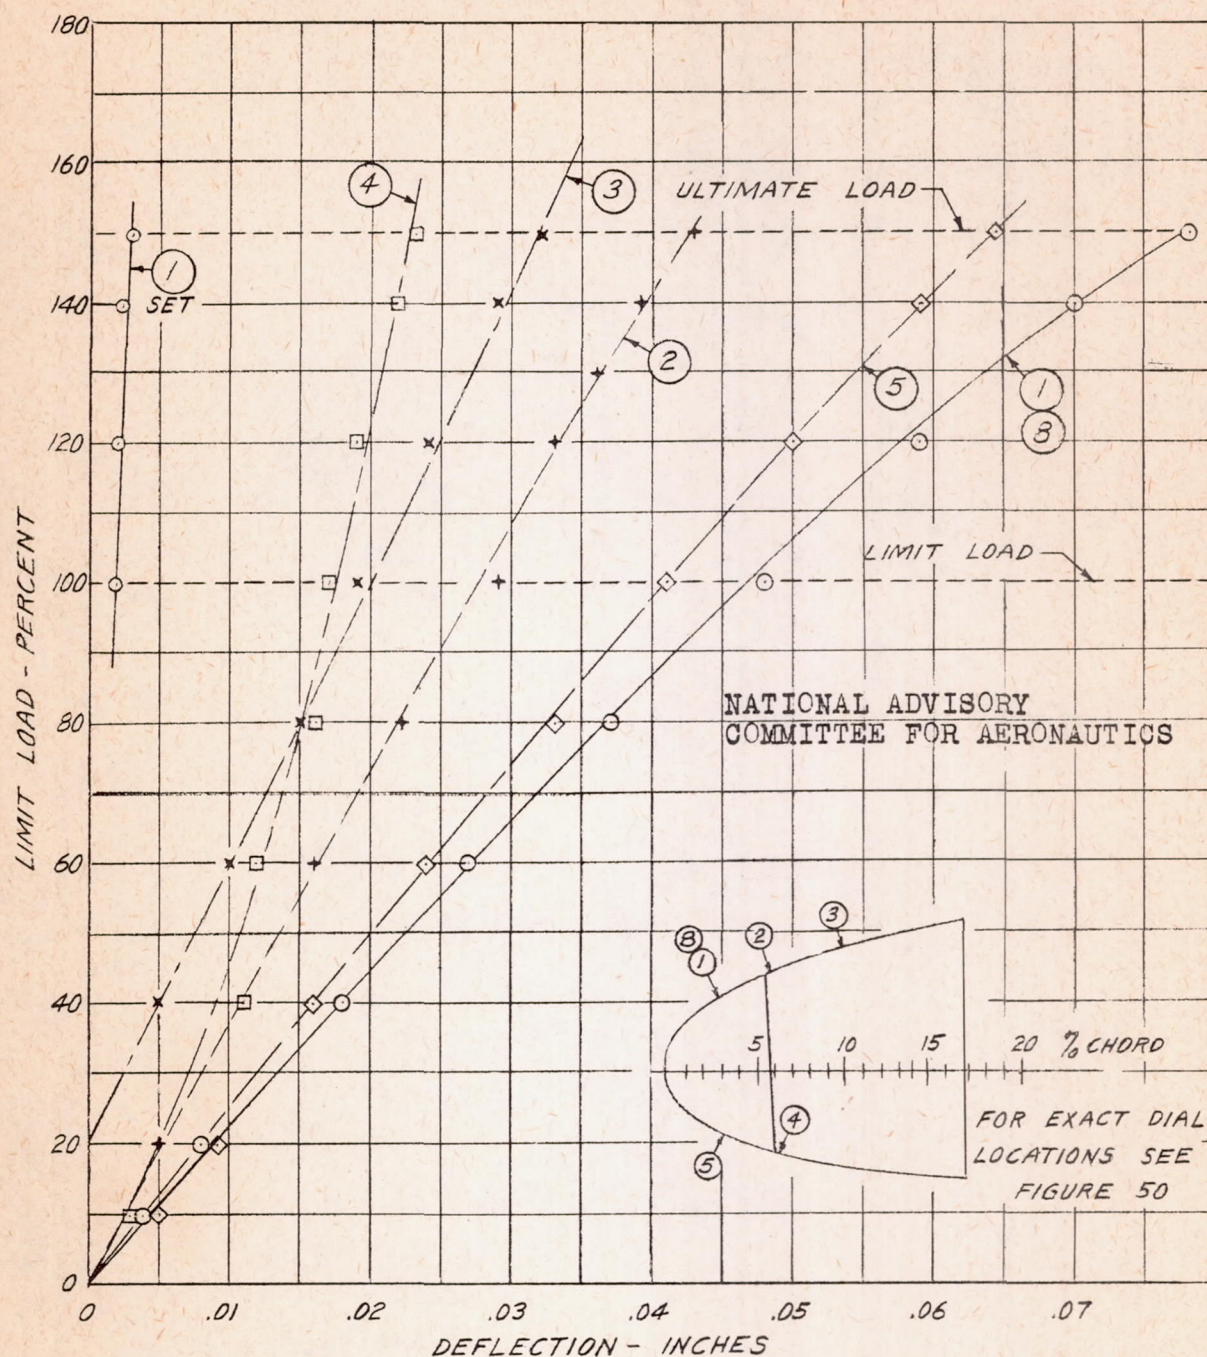
FIGURE 53.- DEFLECTIONS INDICATED BY AMES DIALS DURING STATIC TEST NUMBER FOUR, C-46 WING OUTER-PANEL LEADING-EDGE SPECIMEN.

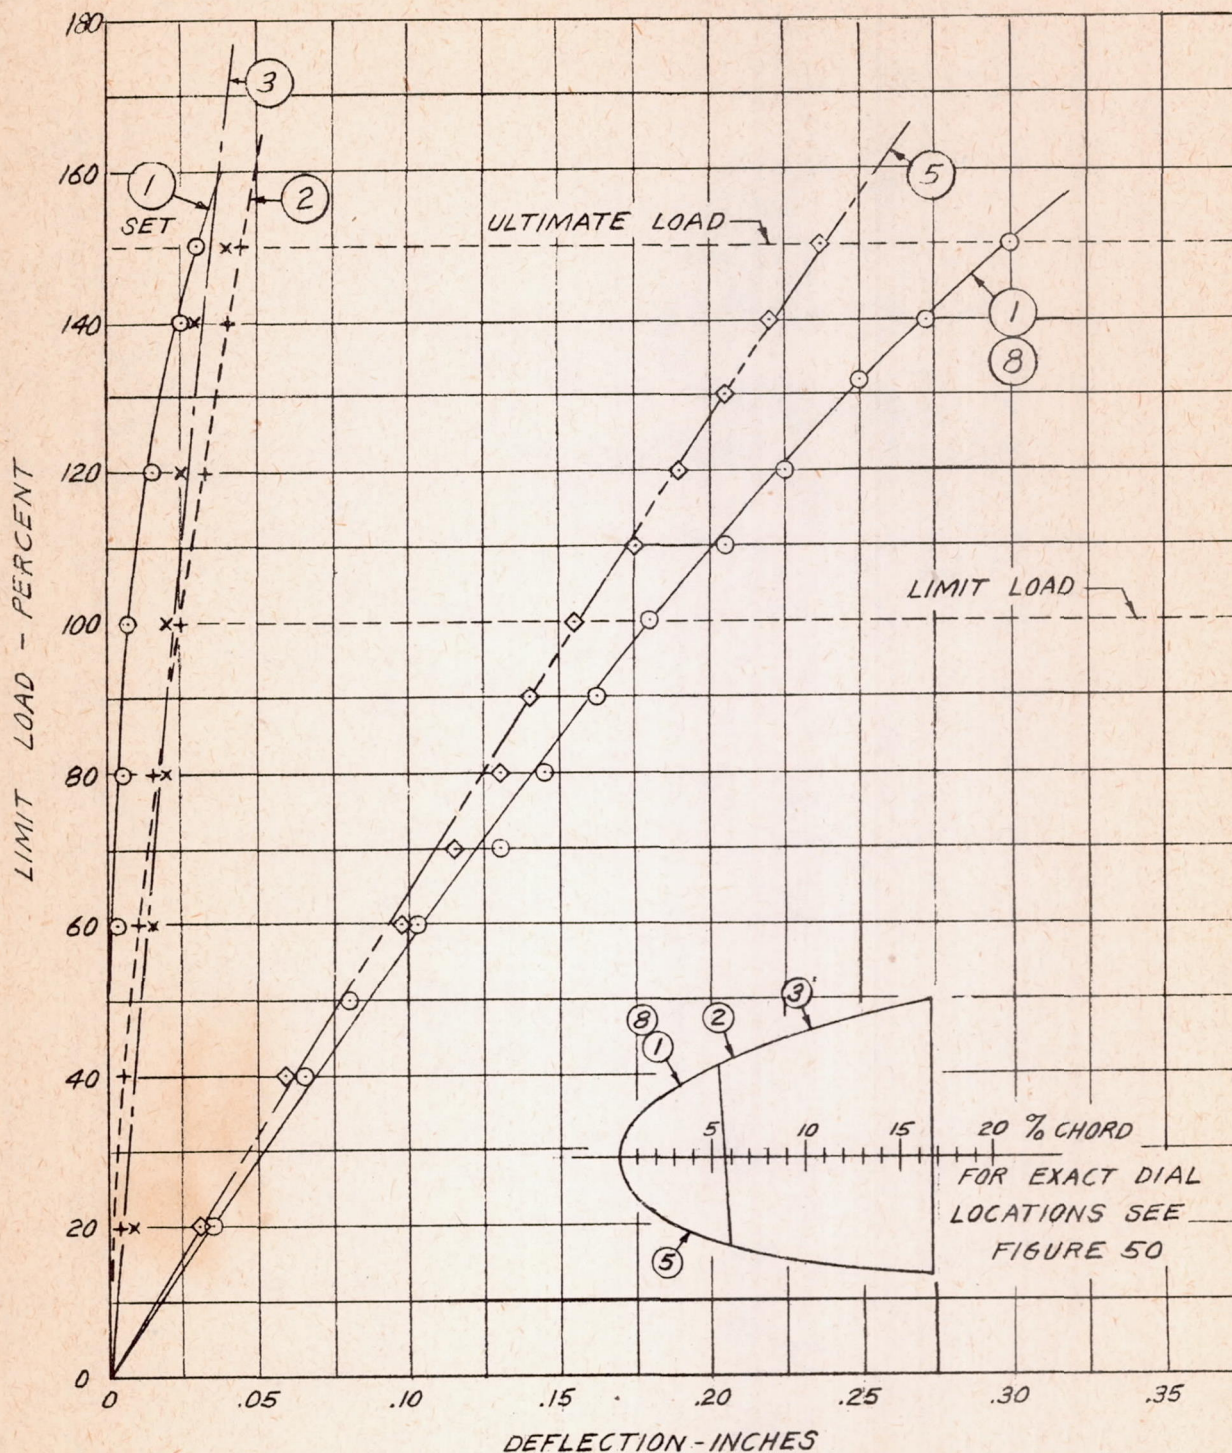
FIGURE 54.- DEFLECTIONS INDICATED BY AMES DIALS DURING
STATIC TEST NUMBER FIVE, C-46 WING OUTER-PANEL
LEADING-EDGE SPECIMEN.
